Hydro acoustic fish population survey

The Relief Channel

27th-28th July 2022

This report provides a summary of results from our recent fish population survey of the Relief Channel between Denver and Saddlebow. The survey was carried out to assess the health of the river and enable successful management of our principal fisheries.

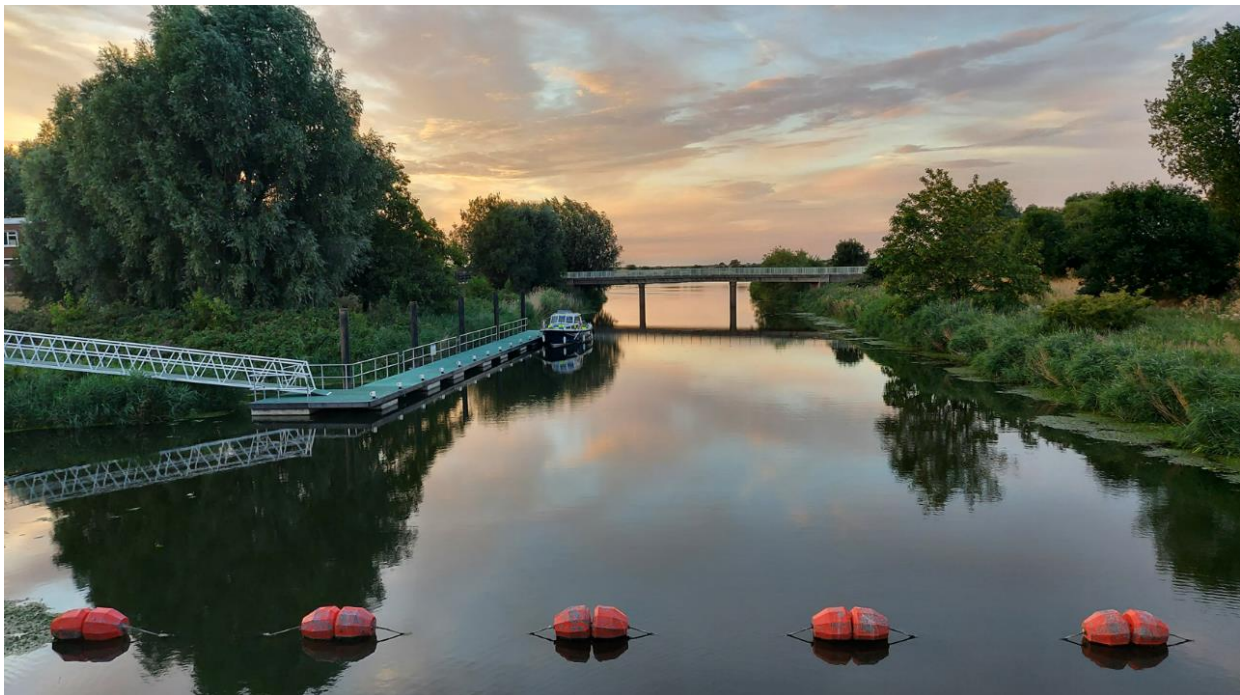
Image 1: The acoustic survey boat Kingfisher moored at Denver - July 2022.

- The pulses of sound are transmitted at 10 pings per second to produce an elliptical sonar beam across the channel width. The transducer is bow-mounted, well forward on the craft, to prevent any background electronic 'noise' from interfering with the acoustic signal. The survey vessel is piloted at approximately 6km/h, working the marginal shelf and any reflected echoes are recorded and analysed by an on-board computer.

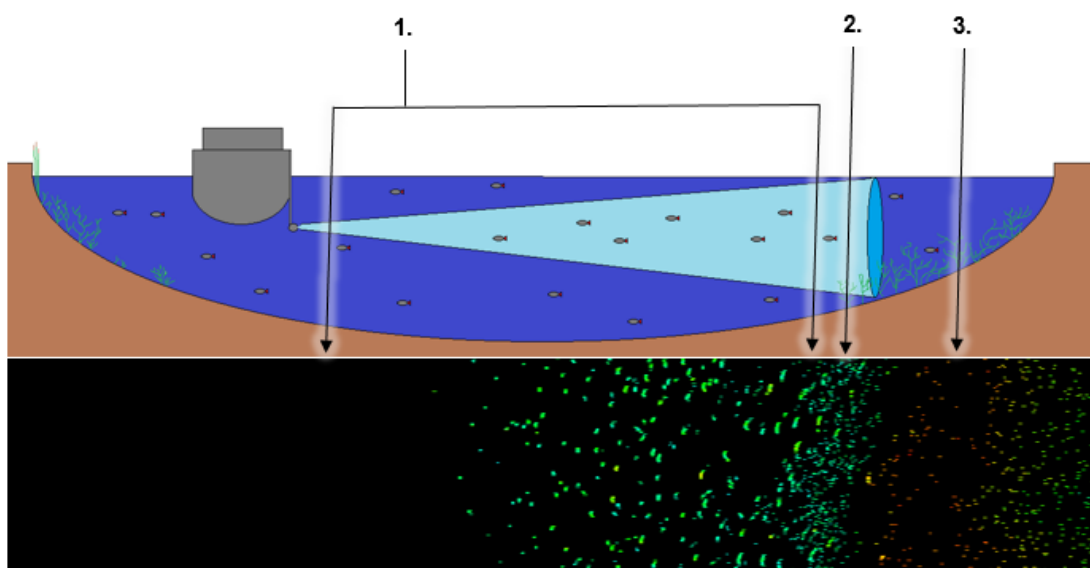
Image 2: Simplified image of the hydro acoustic survey technique.

1. Open water and clearly visible fish echoes.
2. Limit of the 'usable' data surface scatter (light blue) and echoes from rooted plants (light green).
3. Heavy (red and brown) echoes from marginal slope and riverbank.

- Hydro acoustic surveys utilise sound waves (pings) which are fired across the river channel and are reflected off objects within the water column. Depending on the strength of the returning echo the nature of the reflective object can be determined. Solid items such as the far bank, bridge supports and riverbed give extremely strong returns; echoes from fish, or more accurately from their swim bladders, give a moderate return while surface scatter gives much weaker echoes.

- Surveys are conducted at night, since fish are more evenly distributed throughout the water column during hours of darkness, which allows them to be easily distinguished from the substrate, macrophyte growth and bank-side clutter. It is important to avoid periods of boat traffic as the propeller wash can greatly reduce the range of the survey apparatus by filling the water column with air bubbles, which reflect echoes and obscure the images received.

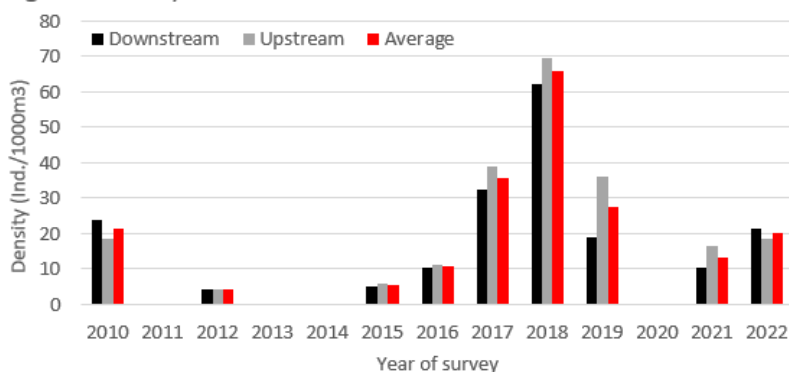
Figure 1: Density estimate 2010 - 2022

Results from the 2022 survey are provided as **Table 1**. Long-term density values are given as **Figure 1**.

The 2022 survey found density and stock distribution to be closely comparable between banks/runs, whether this was coincidence, or due to the change in methodology, is currently uncertain however the river will continue to be sampled in this manner in future years and it is hoped that the data will remain as consistent as observed in this recent survey. The average fish density derived from upstream and downstream passes of the two sample reaches equated to 19 and 21 Ind./1000m³ respectively with a combined population estimate of 20 Ind./1000m³, a value over 50% higher than that found during the preceding survey in 2021.

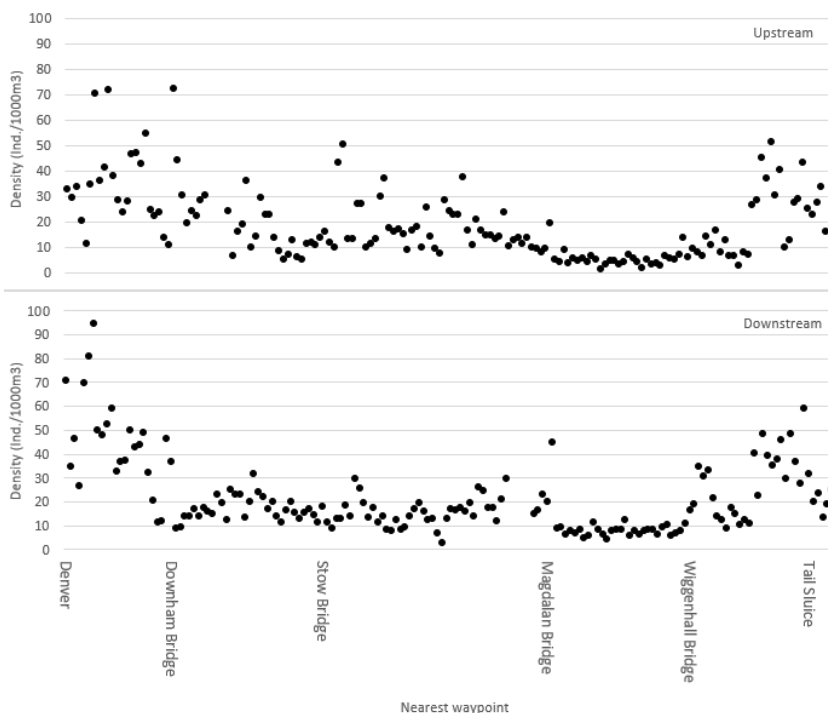
Figure 2: Fish density recorded on upstream and downstream survey passes

Figure 2 (and **Maps 1** and **2** at the rear of this report) display stock distribution expressed via fish density.

The highest fish densities were found close to Denver Sluice; indeed, whilst preparing the survey boat one member of the team was able to identify eight species in proximity of the mooring pontoon. These included roach, rudd, perch, common bream as well as a shoal of juvenile chub, which was observed within the fast water directly below the fish pass outfall.

Both upstream and downstream survey passes noted a reduction in stock between Denver and Stow Bridge with density then slowly climbing towards a second peak observed upstream of Magdalen Bridge within the perennially consistent fish holding area known as the 'Golden Mile'.

A reduced density was apparent on both runs downstream of Magdalen Bridge and fish stocks remained consistently low until Wigenhall Bridge where density increased once more and continued to build to create a third population peak near to Saddlebow.

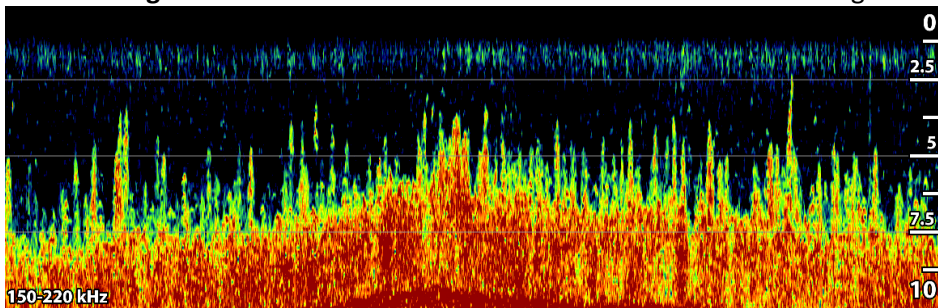
Image 4: Extensive macrophyte growth in the upper channel, note how far this extends up into the water column

A side-scan fish finder is run alongside our survey apparatus and its live view is invaluable for interpreting and validating incoming survey data. During 2022, the side scan unit showed large beds of rooted macrophytes were present which appeared more extensive than encountered during previous surveys on this channel. The increased plant cover may have been due to the latter timing of the 2022 survey, or perhaps growth had been invigorated by the recent warm conditions. Whatever the cause, the prevalence of macrophytes growth became problematic within the upper reaches of the channel by reducing survey range and requiring the acoustic beam to be angled slightly upwards to avoid spoiling the acoustic image received. An example of the macrophyte growth is shown below as **Image 4** and an image from the side scan is displayed as **Image 5**.

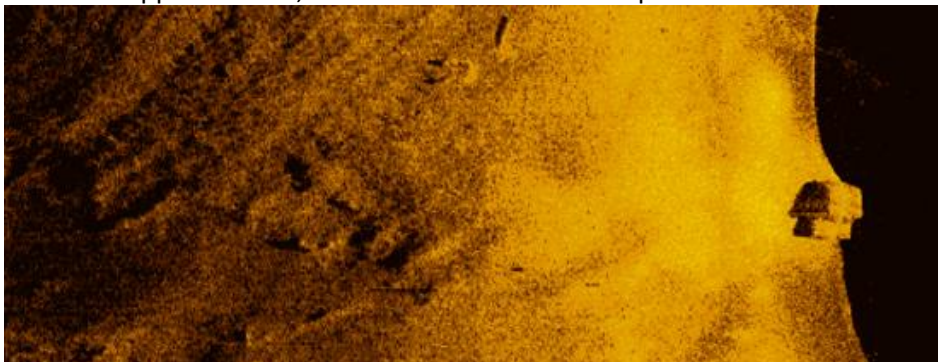
Image 5: Weed-beds and unusual and regular shaped object laying on the bottom of the channel which appears to be a small angular vehicle somewhat akin to a vintage Mini (or Postman Pats van?)
